Seismic Testing of Fire Stopping Products:

Can we build to withstand an earthquake?

By Rakic, J. , McDonald, S. , Henry, J. & Todd, C.

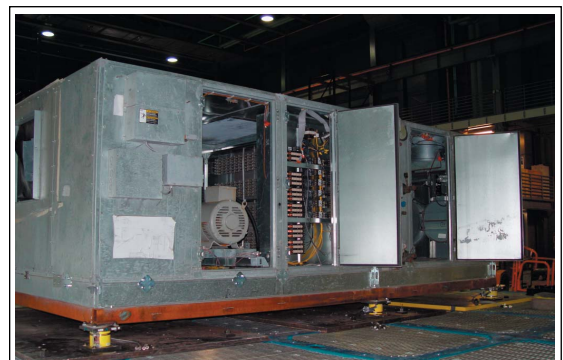
FEMA 461 / June 2007

Interim Testing Protocols for Determining the Seismic Performance Characteristics of Structural and Nonstructural Components

Interim testing protocols were developed for **Quasi Static Testing** and for **Shake Table Testing** along with Functional Performance criteria and Anticipated Damage States.
